SLAG VALORISATION SYMPOSIUM

19-20 March 2013
Leuven, Belgium

RECOVERY OF PADDY FIELD DAMAGED BY TSUNAMI AND EARTHQUAKE USING STEELMAKING SLAG

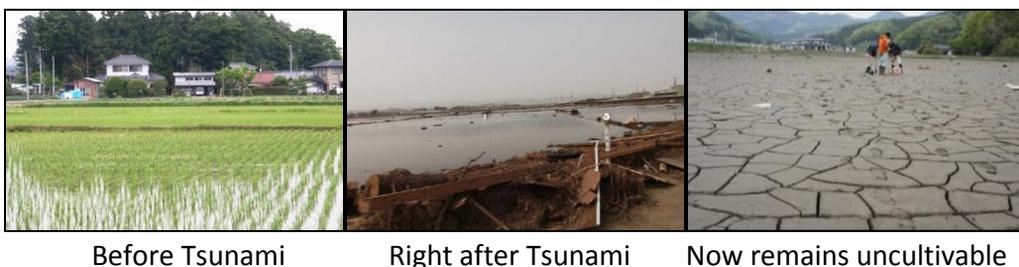
Figure 1: Damage to paddy field in Sendai area

Before Tsunami

Right after Tsunami

Now remains uncultivable

The entire world has been astonished by the great earthquake happened in Japan on 11th March 2011. Unimaginable damages occurred, not just only by the earthquake itself but the horrible Tsunami it brought. Sendai area, which is quite close to the epicentre, could not escape from the claws of Tsunami, although it is such smooth ground rather than canyon coastal. Figure 1 accounts the horrible damage. Almost 150 km² of farmland in the entire Miyagi area (including Sendai area) has been immersed, of which nearly 90% is paddy field. That means, a fertile granary, as we so remembered, was gone.

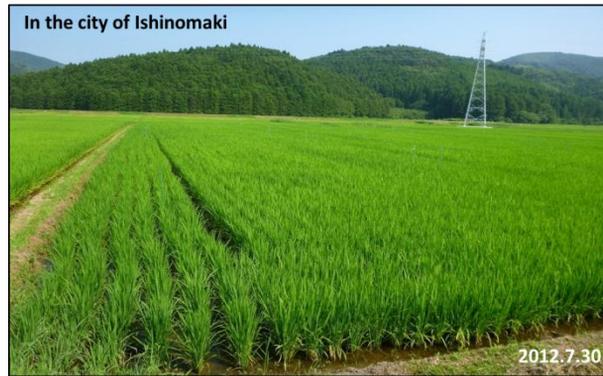
Figure 5: Attempt on paddy cropping in salted soil with steelmaking slag spread

As shown in Figure 5, some trials have been made by current authors. Paddy has been planted in salted soil with steelmaking slag spread as fertiliser. The existence of steelmaking slag promotes the paddy growth during sprouting and maturity season. Also within those periods, the paddy grows even better than in the normal cropping condition.
